USAAMRDL TECHNICAL REPORT 72-52

**INVESTIGATION AND EVALUATION OF
NONFLAMMABLE, FIRE-RETARDANT MATERIALS**

The objective of this study was to evaluate the feasibility of containing or restricting in-flight or postcrash helicopter fires to allow the crew and passengers to escape or remain within a livable environment until the fire could be extinguished or the burning fuel consumed.

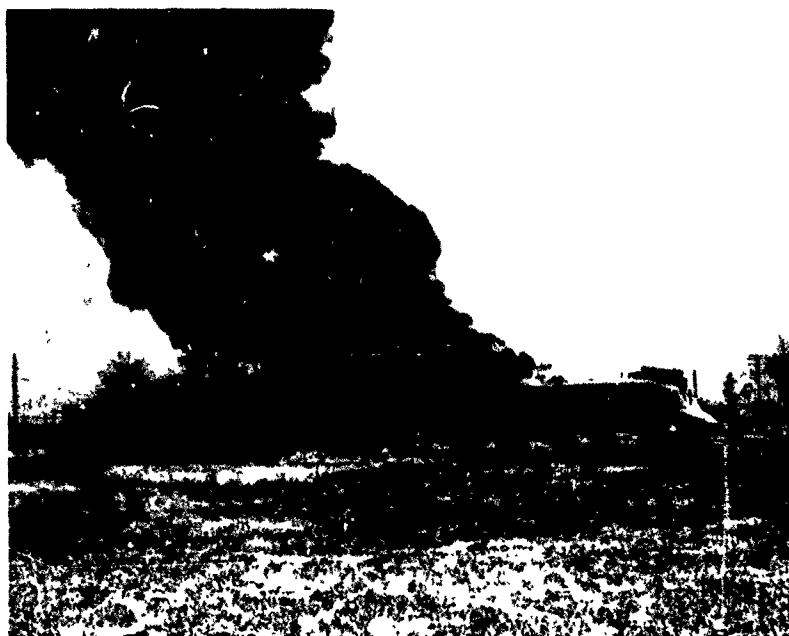
Figure 11. CH-47 Fire in Progress Soon After Ignition.

was trapped underneath the helicopter. Inclement weather conditions prevailed, with rain, sleet and snow falling throughout the test period. Wind of 10-20 mph was blowing along the length of the helicopter from the cockpit toward the aft section. Figures 10-13 show the progress of the CH-47 postcrash fire.

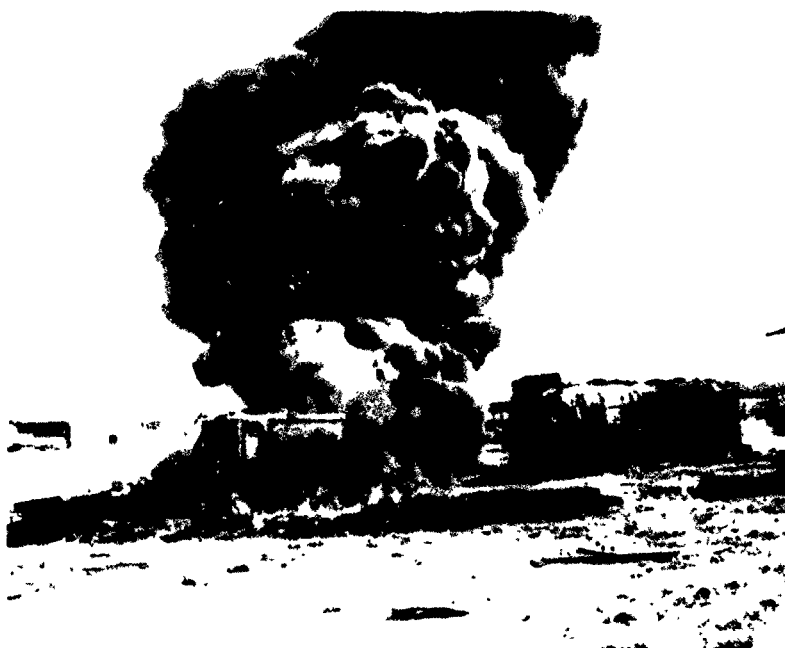
Figure 15. UH-1D Postcrash Fire After 30 Seconds.
